The Use of Geofibers and Synthetic Fluids Kwigillingok Airport

FINAL REPORT

Report # RR08.14

February 2011

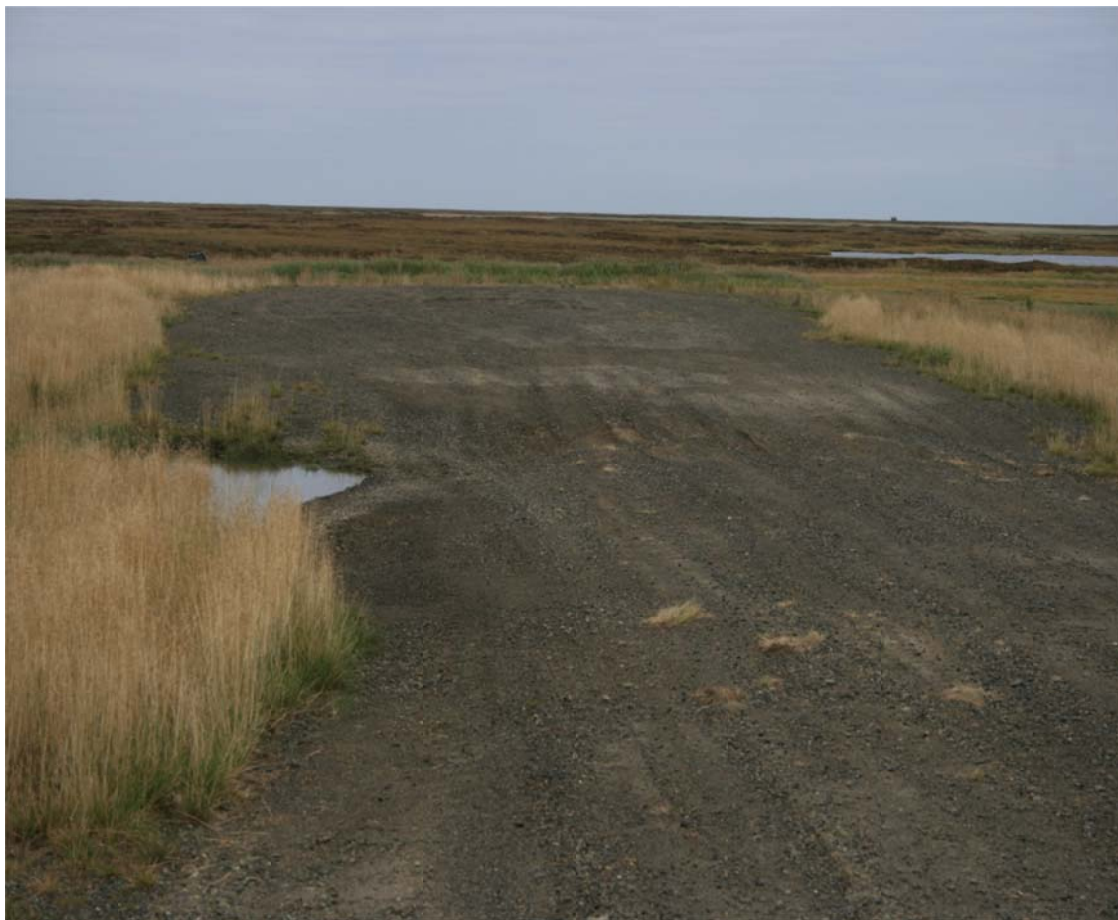
There is a 500 foot section on the northern portion of the runway that is not used. The pilot explained that this portion of runway is not used because it is difficult for pilots to slow down before a large bump is reached which can make the plane re-launch. Upon further investigation into the northern end of the runway it was evident that there is some melting permafrost in this area. The thaw-pond forming from this is shown as [Fig.1](#). The northern end of the runway was apparently slightly higher in elevation than the rest of the runway, this is evident in [Fig.2](#) which was taken approximately 800 feet from the northern end. Also, shown in [Fig.2](#) are the cones which mark the section of runway that is avoided.

Figure 1: Melting Permafrost puddle on the northern end of runway

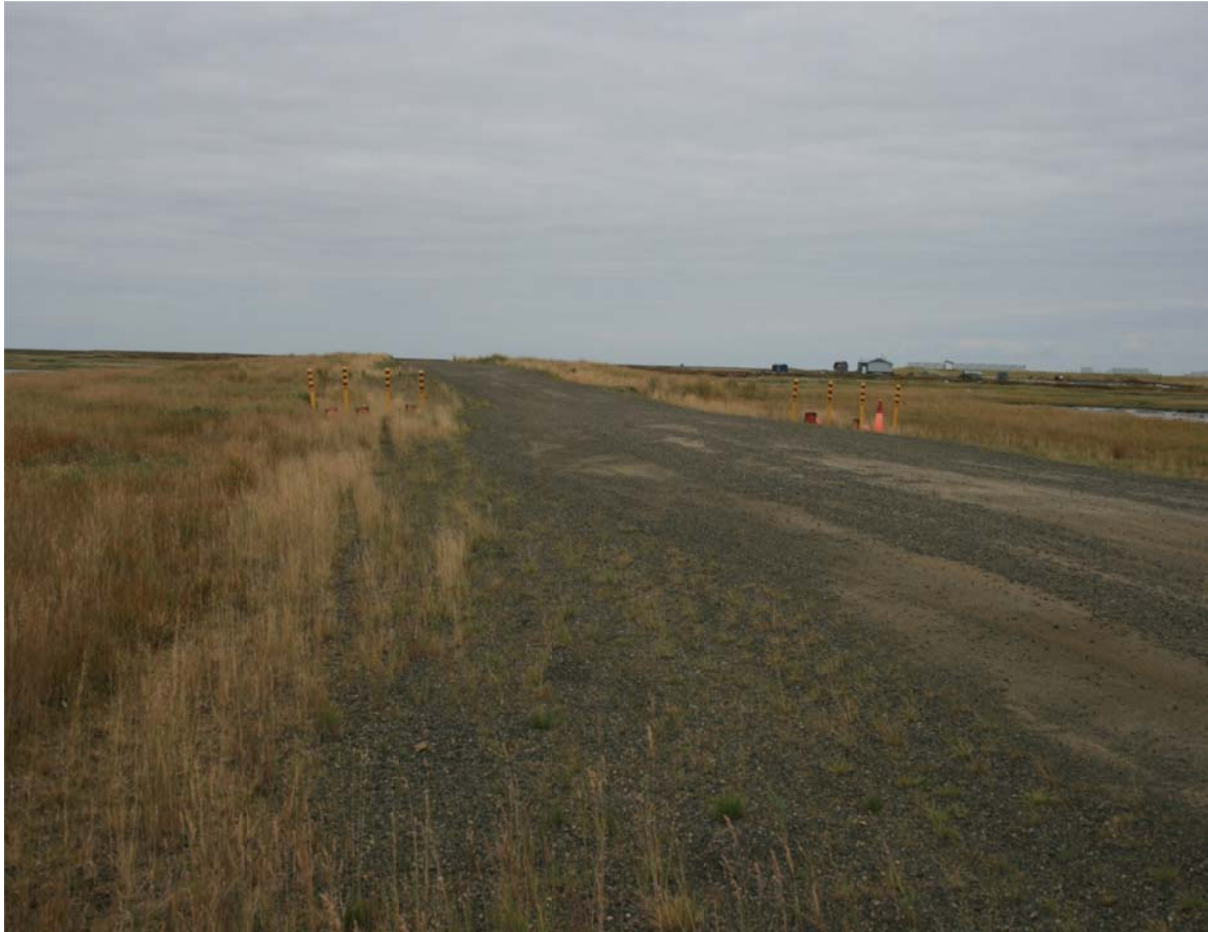
Figure 2: Elevated northern section of runway unused for airline traffic

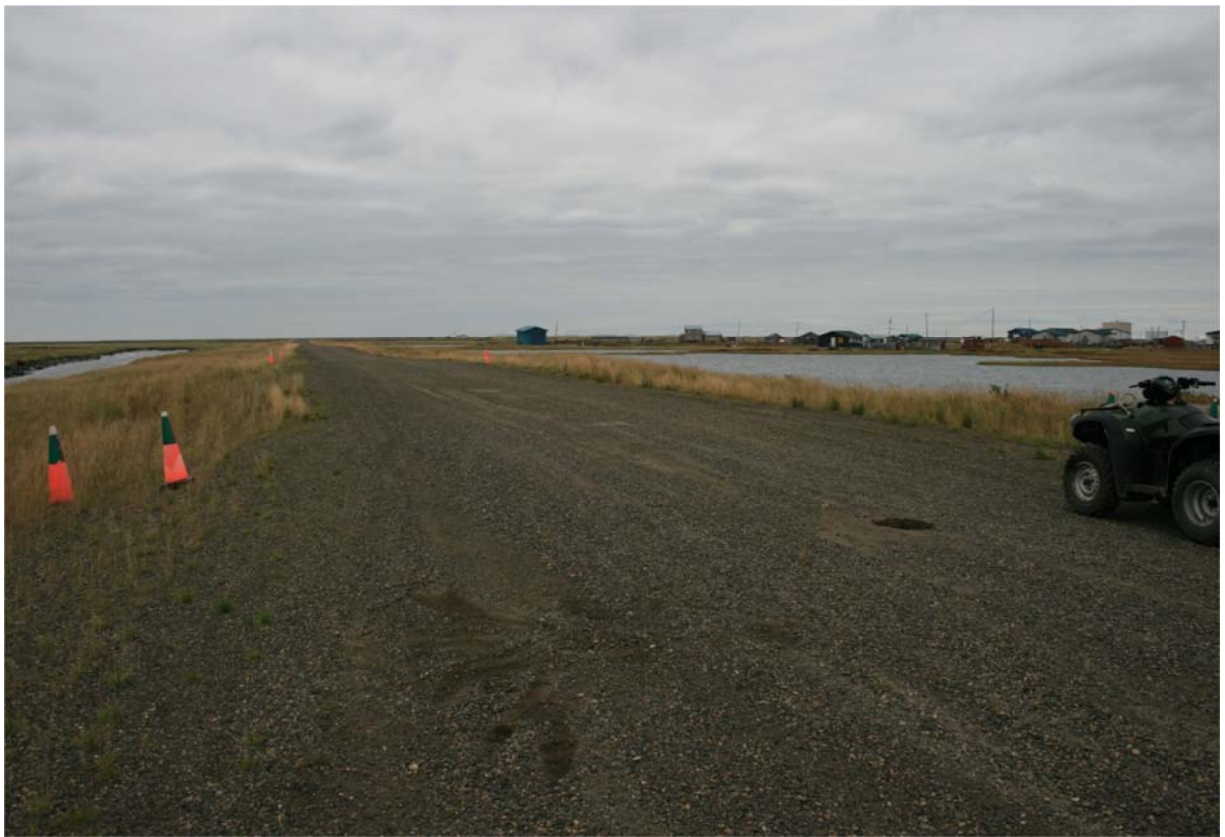
The depth of the gravel on the runway surface was checked on the northern and southern sections of runway, also on the sides of the runway. The depth of gravel at both the north and south ends of the runway was approximately eight inches; no further digging could be done after this depth was reached because it was heavily compacted and only a spade shovel was used, the image showing where the hole was dug is shown as [Fig.3](#). One hole was dug on the side of the runway to find the depth of gravel throughout the runway; this showed the gravel to be nearly one inch thick on the side of the runway which is shown in [Fig.4](#). It is apparent that the many years of grading had resulted in the variable thickness of the gravel surface. However, it is not clear whether this is due to differential settlement. Unfortunately, we did not have the equipment to determine this.

Figure 3: Area disturbed in front of picture is where eight inches gravel was found

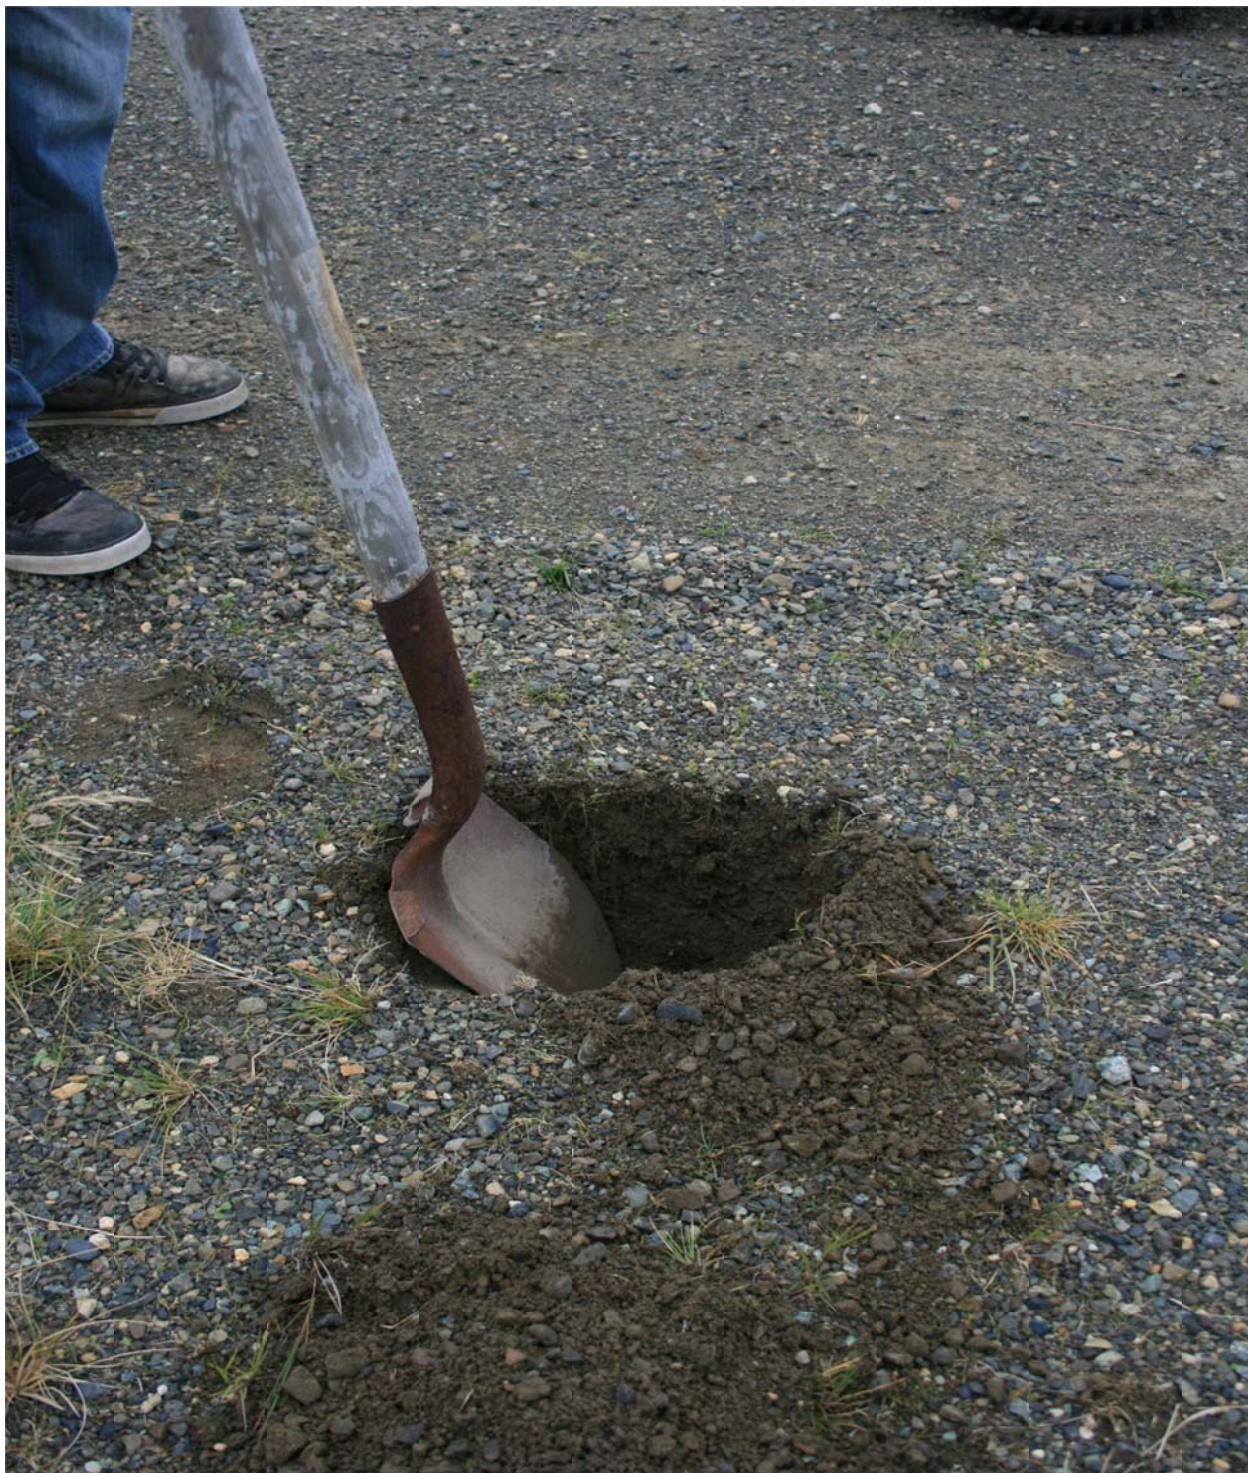
Figure 4: Hole on side of the runway showing a shallow depth of gravel

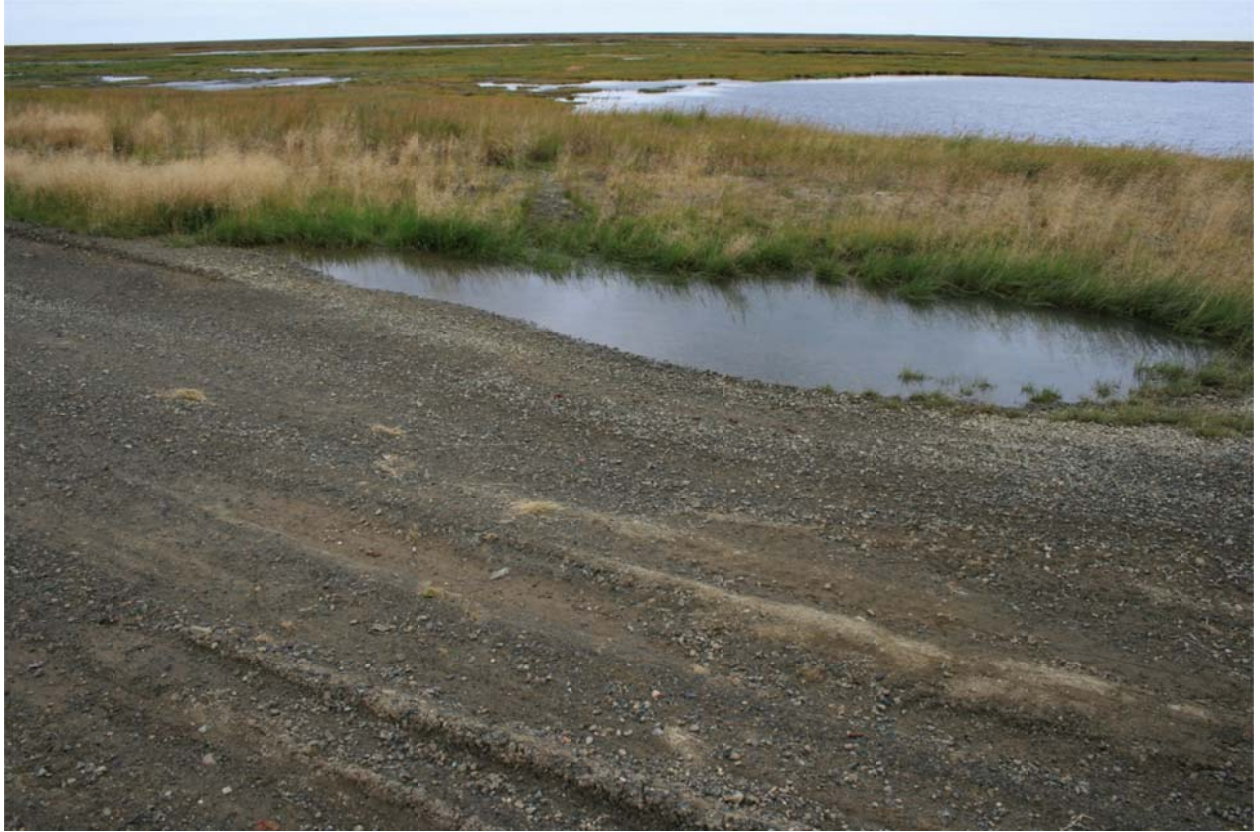
There are few ruts and potholes on the Kwigillingok runway. However, the northern end of the runway where the permafrost has melted the subgrade has become very soft [Fig.5](#).

Figure 5: Ruts caused from melting permafrost on northern end of runway

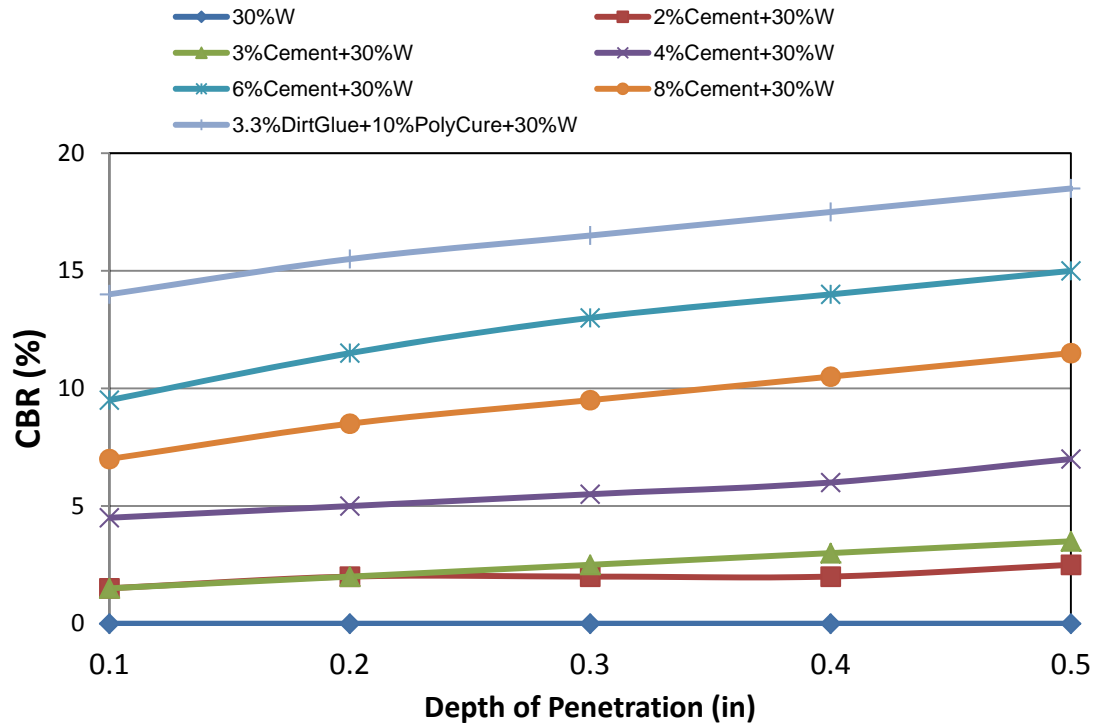
The addition of Portland cement does seem to have an influence on the CBR value; however there is little influence on the moisture contents of the samples. The control sample when tested in the CBR apparatus had zero bearing capacity. The results of the CBR testing are presented in [Fig.11](#), where the CBR value is shown versus the depth of penetration for the samples. There are two things of interest in this figure, the first and most obvious is the increase in CBR performance with increasing up to 6% cement content, the sample with 8% cement did not perform as well as the 6% sample. It should be noted that as the cement percentages increased there was increased difficulty in mixing the samples homogenously, this probably explains the

decrease in bearing capacity for the 8% sample. The second interesting piece of information that comes from [Fig.11](#) is the strain hardening achieved with increasing amounts of Portland cement.

Figure 11: Depth of Penetration versus CBR value for samples treated with cement and DirtGlue
